## **Buildings update 1/2025**

## FIELD INSPECTIONS REPORT

**Project:** Bridgeport Library – Lower East Side  
1174 East Main Street  
Bridgeport, Connecticut

**Date of Inspection:** December 2, 2024  
**Time:** 1:00 PM  
**MHAI Job #** 22-193

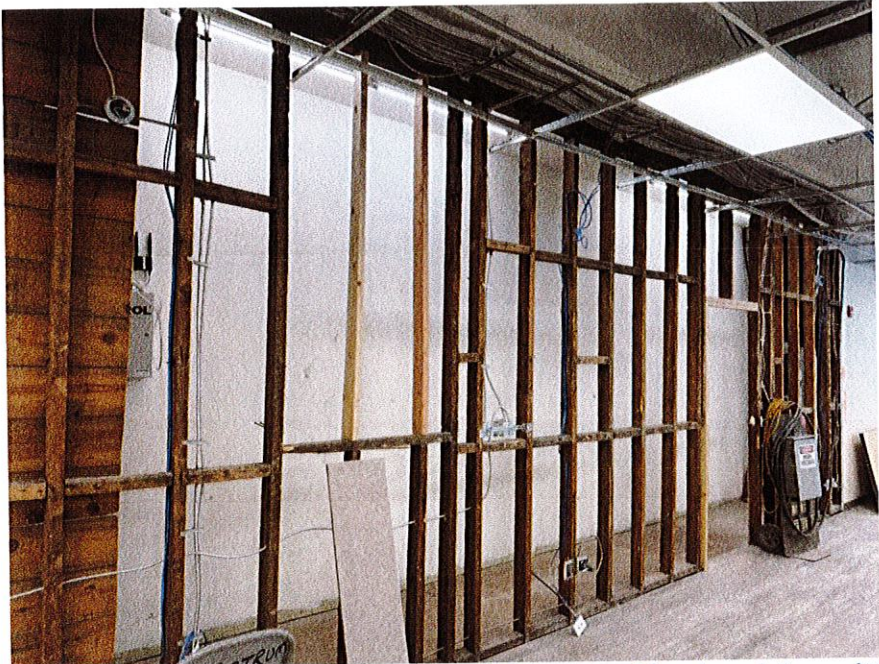
- The existing second floor joists were found to be supported on the existing wall, plan left of the existing stair to the second floor. This will require additional support for the ends of these joists, with the wall being removed. Refer to Photo 1.

*Photo 1: Existing wall planned for removal, found to be a bearing wall based on existing conditions*

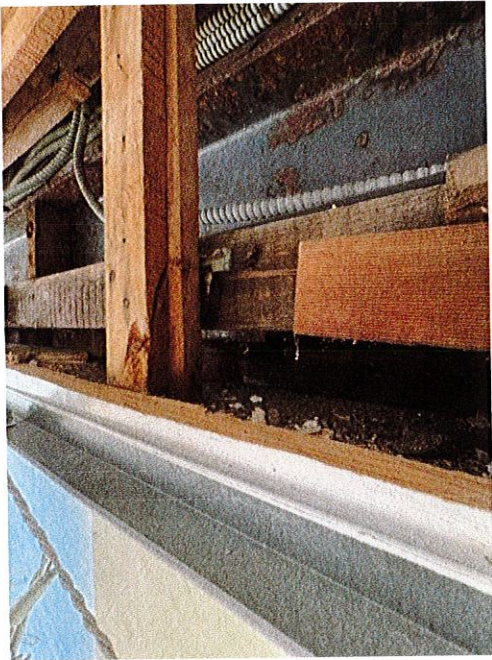
- Along Grid X.1 existing steel columns were found below the beam at the second floor. However, the beam is continuous over the columns, additional stiffeners and a revised connection will be required for the new steel columns coming from above. Refer to Photo 2.

*Photo 2: Existing continuous steel beam at Grid X.1*

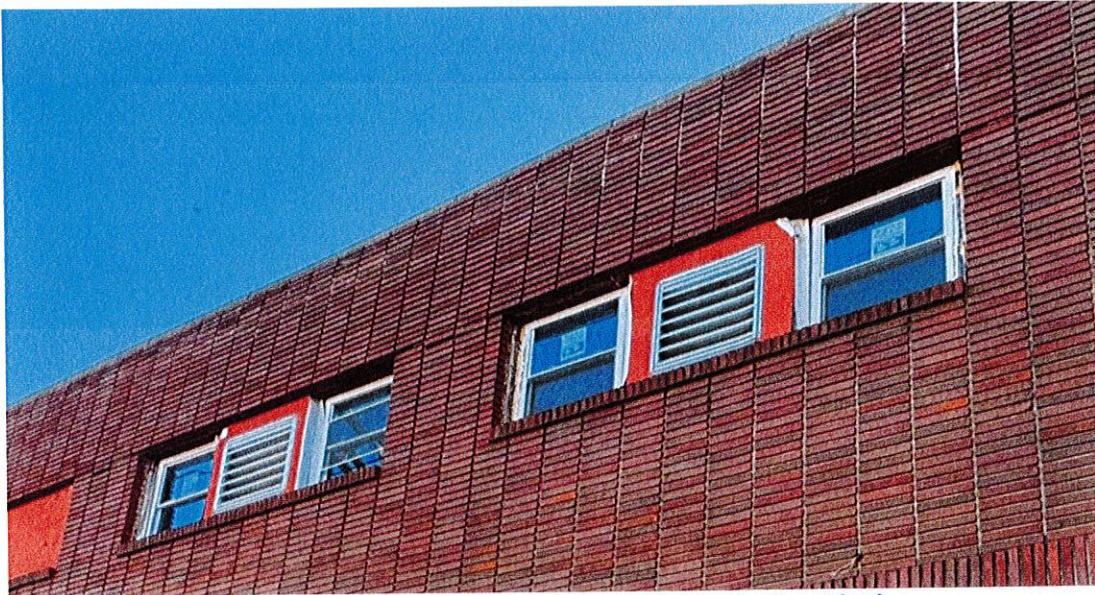
- Existing lintels along grid X.2 were observed to be deteriorated, causing damage to the adjacent brick. Remedial actions are required. Refer to Photo 3.

*Photo 3: Existing deteriorated lintels causing damage to adjacent brick*

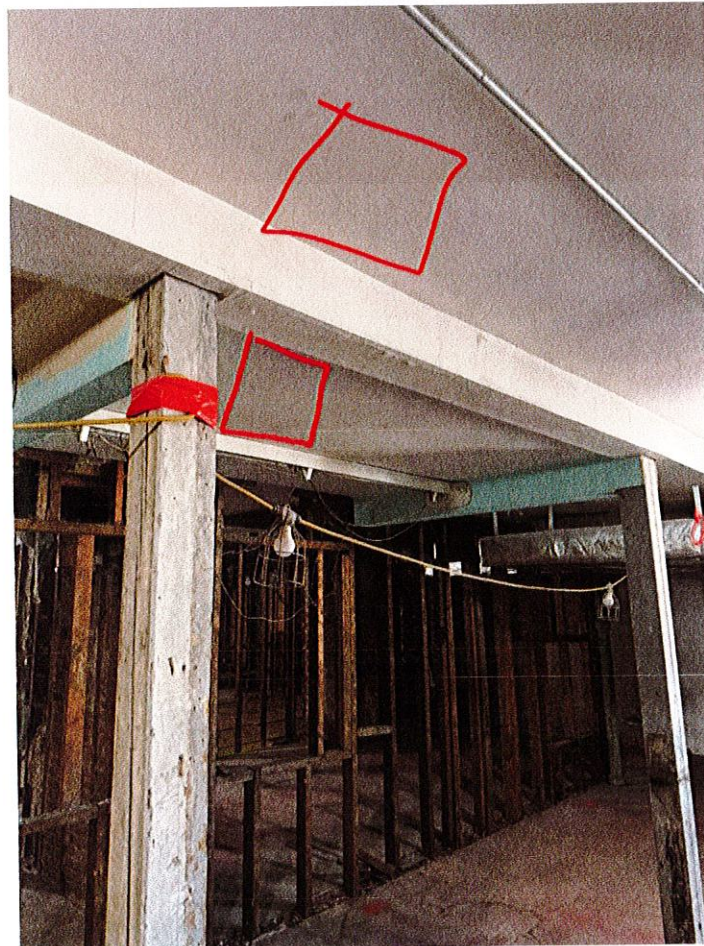
- Existing hard ceilings are in place on the second floor, blocking access to the roof framing. **MHAI requires 3 exploratory openings in the ceiling of the second floor to verify the roof framing at these locations.** Please see Exhibit 1 and refer to Photo 4.

*Photo 4: Provide exploratory opening on each side of "soffit" to expose roof framing.*

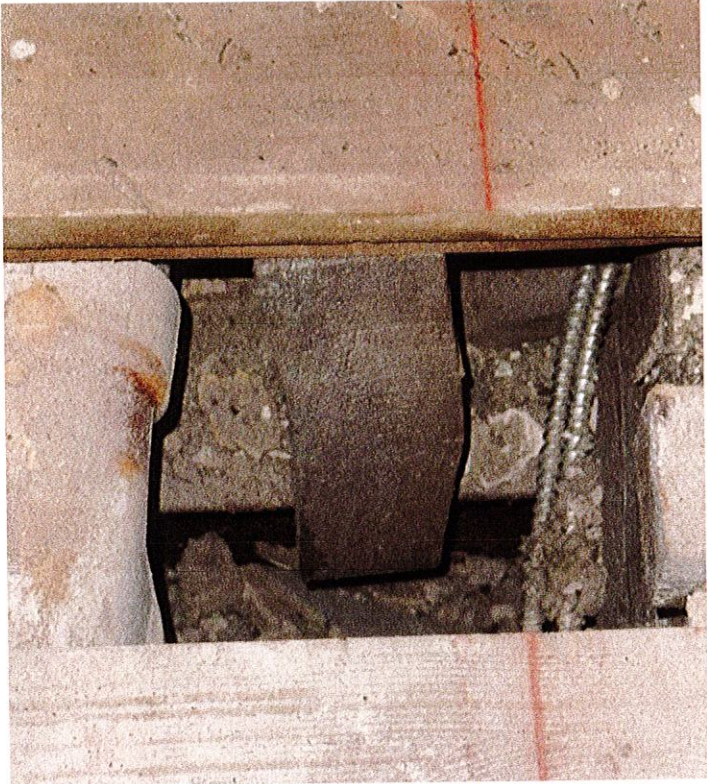
- An existing second floor joist that was visible, was observed to have buckled at the end of the joist. Refer to Photo 5. This joist will need to be repaired. Additionally, the other existing joists that were not visible will need to be reviewed. **MHAI requires that the ceiling of the first floor be removed below the entire footprint of the second floor, to inspect the bearing ends of the existing joists and to verify framing direction and sizes of the second-floor framing that were not accessible.**

Photo 5: Existing observed buckled joist

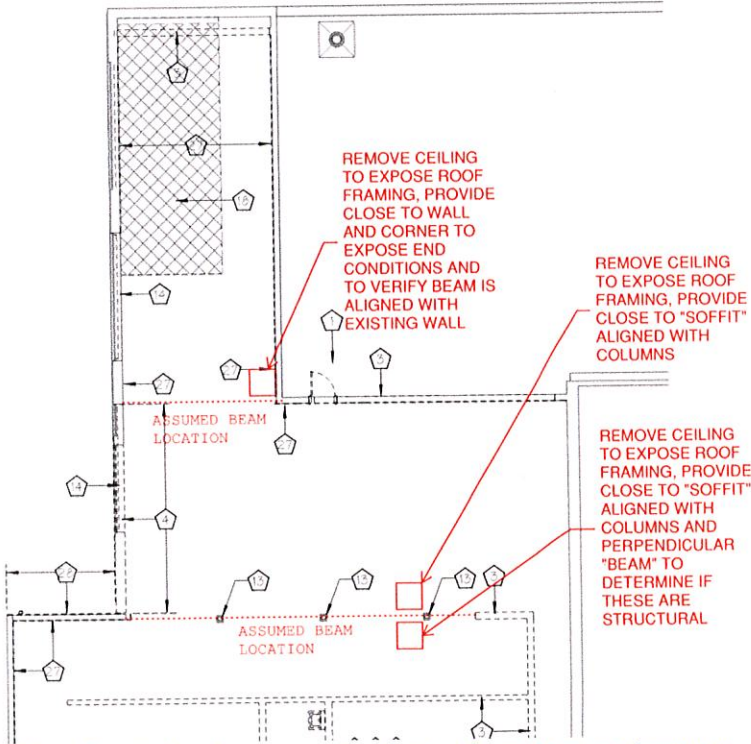
Exhibit 1: Required exploratory opening locations for roof framing observation
