Maintenance managers report 11/2023

Burroughs window meeting

RE: Bridgeport Public Library
Field of Roof: Field of Roof - 18,000 sq. ft.

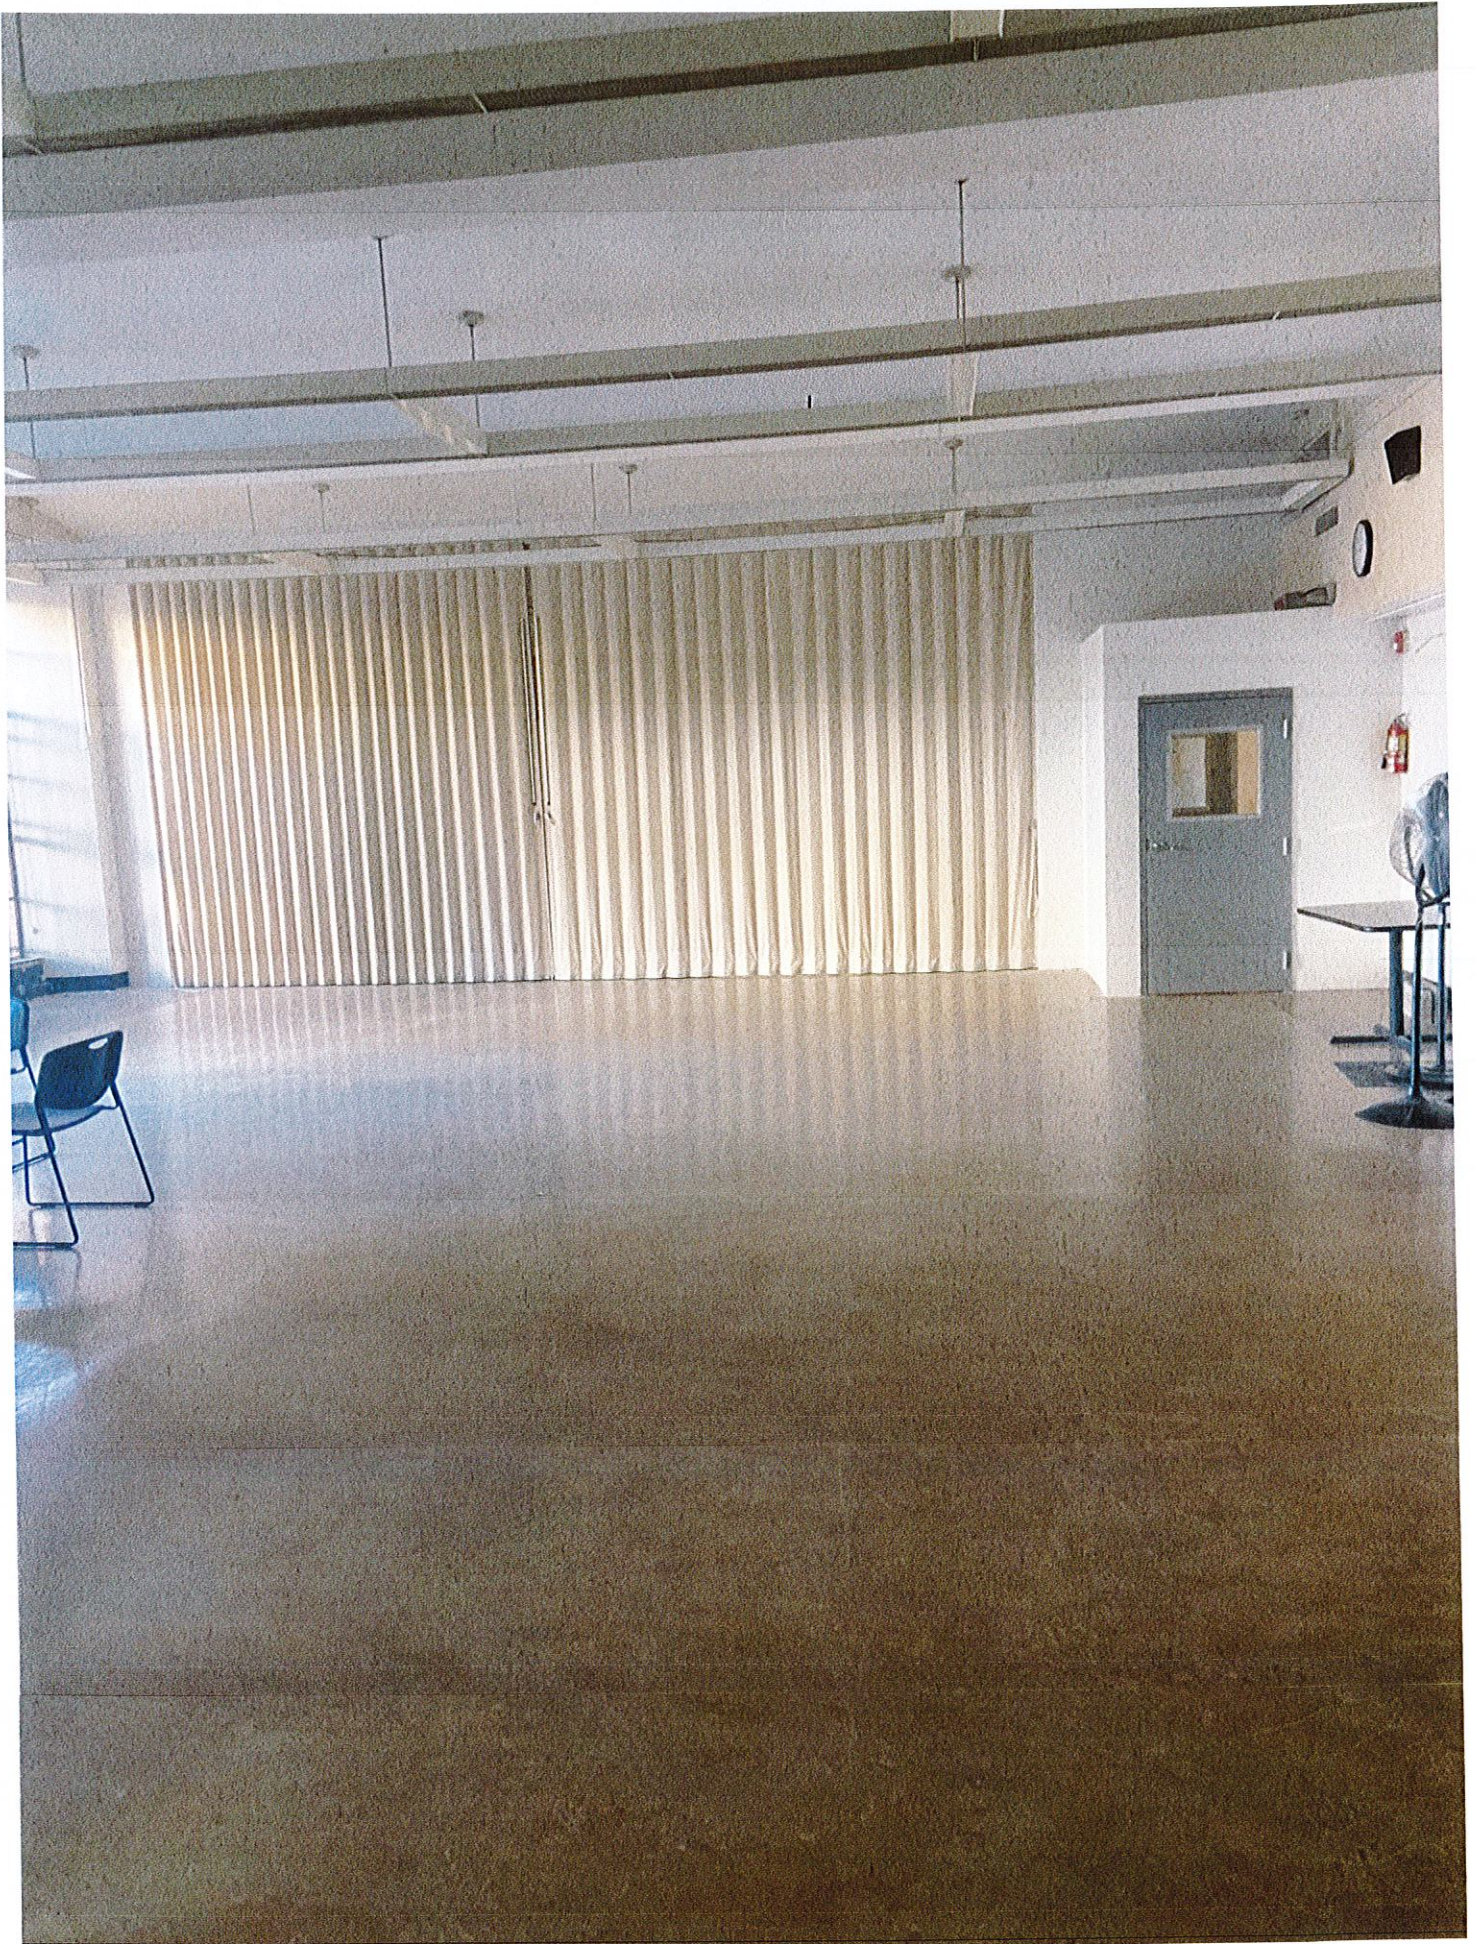
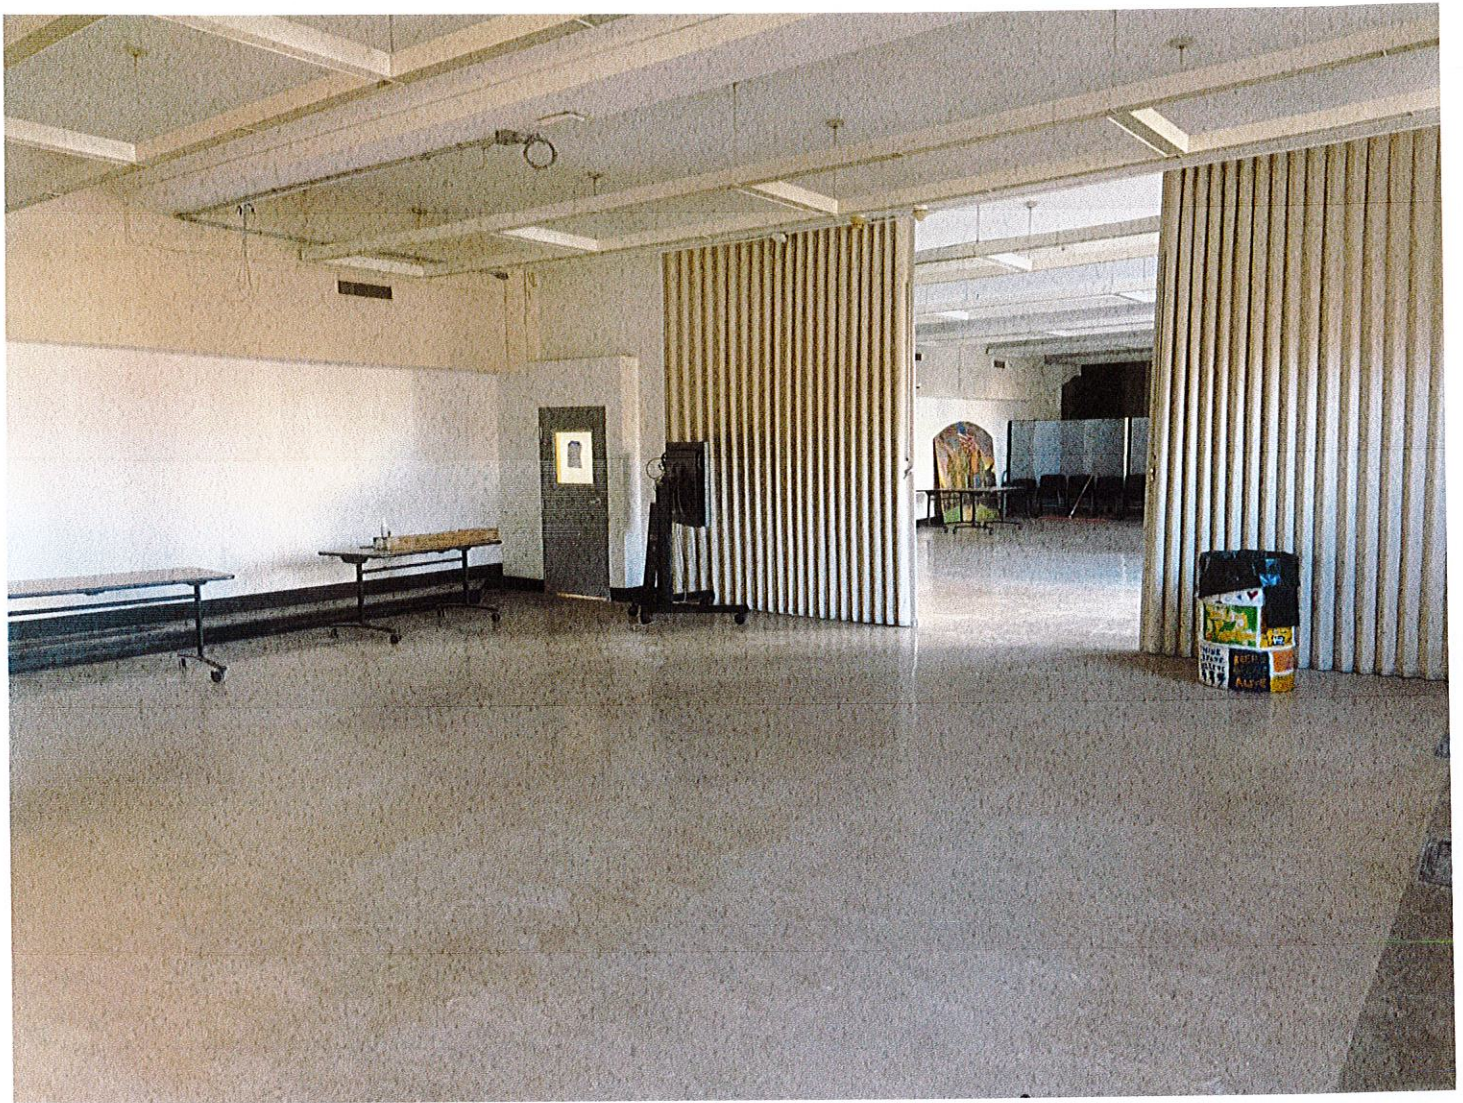
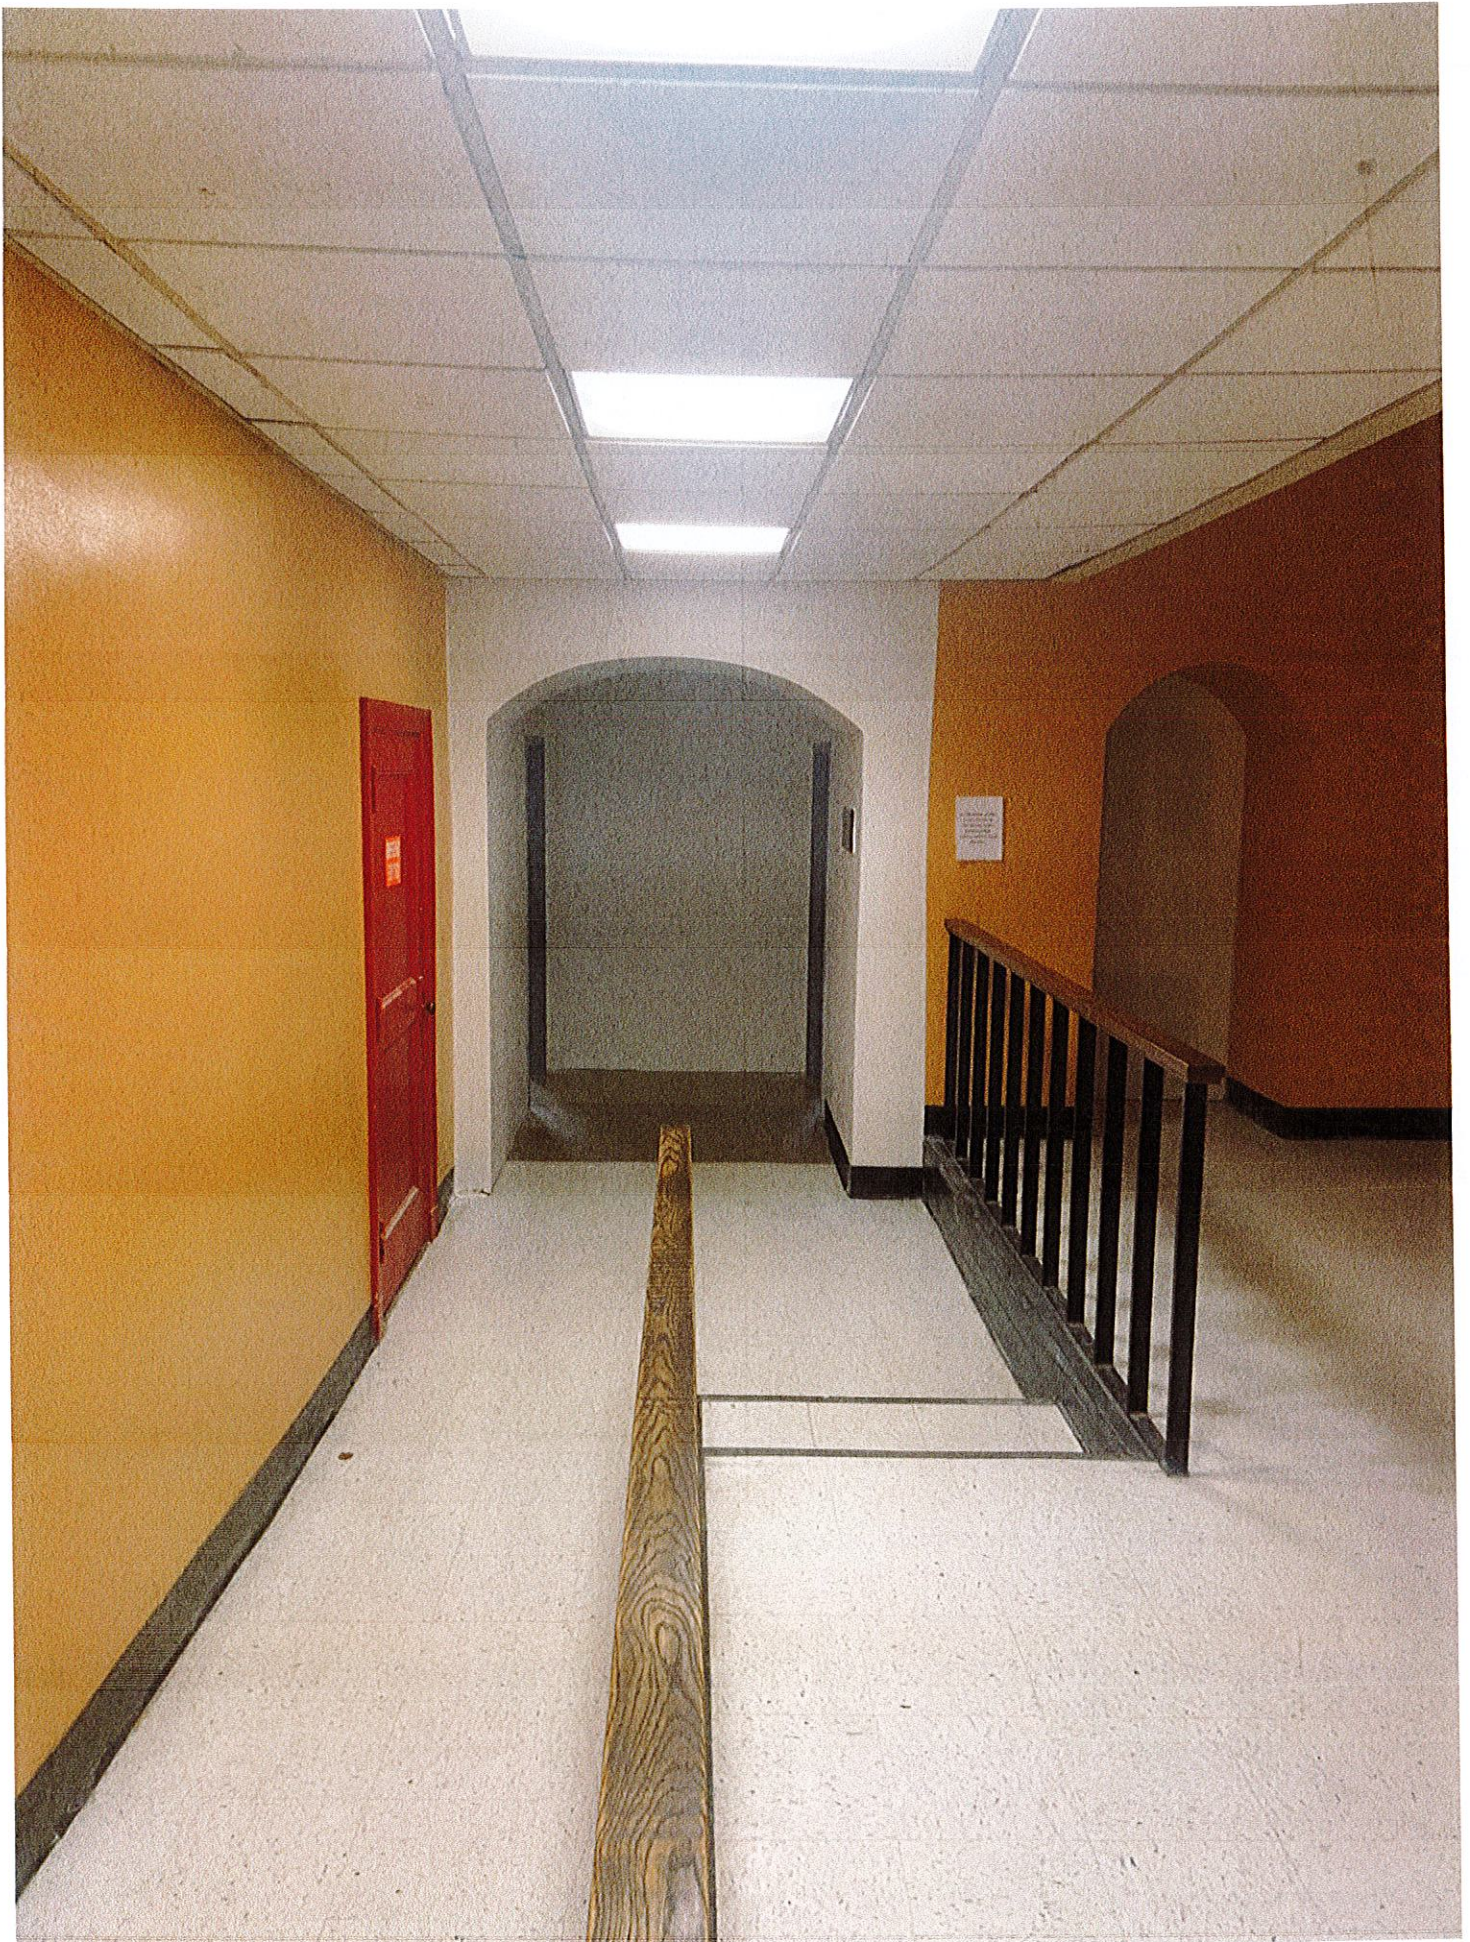
- *Accordion door and vestibule is completed. We are painting and installing cove base in house. (See attached pictures)**
- *We are currently in talks with Bismark construction to see where we can cut cost and find a way to possibly proceed with window project. Perhaps in phases. (see attached notes from meeting)**
- *Solar panels were delivered to Burroughs and are to be brought up to the roof via a crane. This is supposed to happen in the very near future but we do not have an exact date yet.*
- *Smoke beam repair that was previously approved by the board, is waiting on the ordered parts to schedule repair.*

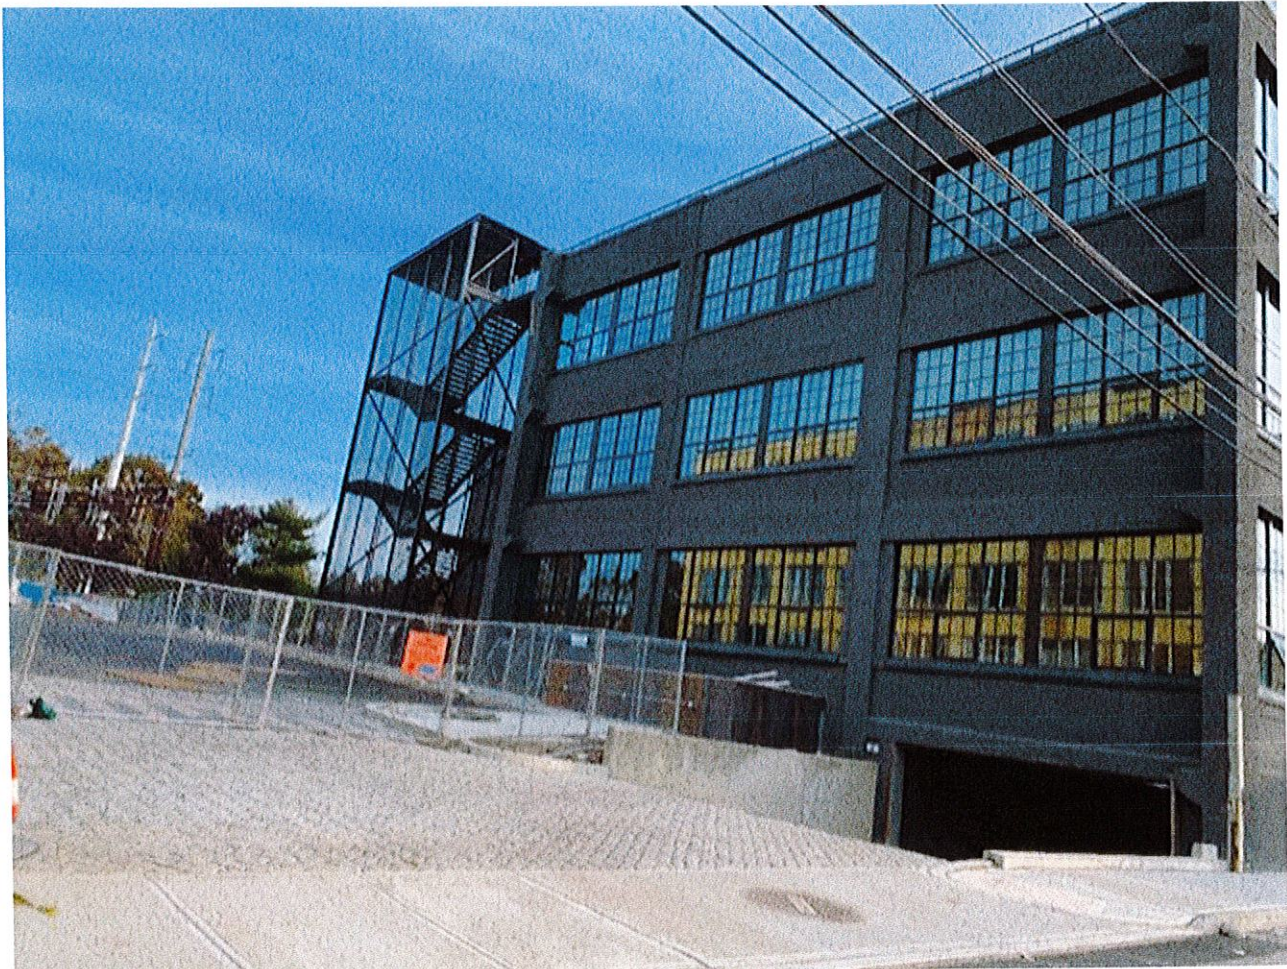
From: Kevin Geignetter <Kevin@jgglassco.com>
Sent: Wednesday, November 8, 2023 9:23 AM
To: Gregory M Raucci <gmraucci@bismarkconstruction.com>
Cc: David Otero <dotero@bridgeportpubliclibrary.org>; Kris DiCocco <KDiCocco@bismarkconstruction.com>
Subject: Kawneer window

- Kawneer windows vs Quaker windows could be very cost effective. See attached picture below with a similar style window (Kawneer) to what we have. This was a recent install in Norwalk, CT. You will notice they have a similar design. We are not obligated to remain historically accurate as the building is not a historical landmark yet. We may not have that option in a few short years. Again you will see the Kawneer window is not that different and could amount to a substantial savings. I noticed 2 replacement windows in the pop room that do not match our others. How historically accurate do we want to remain, exact or similar? Thoughts on window types are welcome.

- My thoughts are to do the windows in phases. Starting with the front of the building. There are 28 windows. Thats less than half. If we go with the Kawneer we can cut the materials cost significantly. Quaker windows are 14+ weeks lead time. Kawneer is 3+ weeks lead time. Bismark is going to give us 2 revised quotes to do just the front including the 3rd floor although Tom expressed that the 3rd floor takes less precedence . I think its best at the to do all at once for uniformity, consistency and to not have to go back and work on the front side. We would have to pay twice for permits and the like if we did. If all works out we can have the front done by the spring time in this fiscal year (2023) and then plan out what we can afford to do in the next fiscal year 7/2024. I would thing the next phase would be State st. side.
